Wilburne house, barns, and tenant house

INVENTORY FORM FOR STATE HISTORIC SITES SURVEY

CT-97

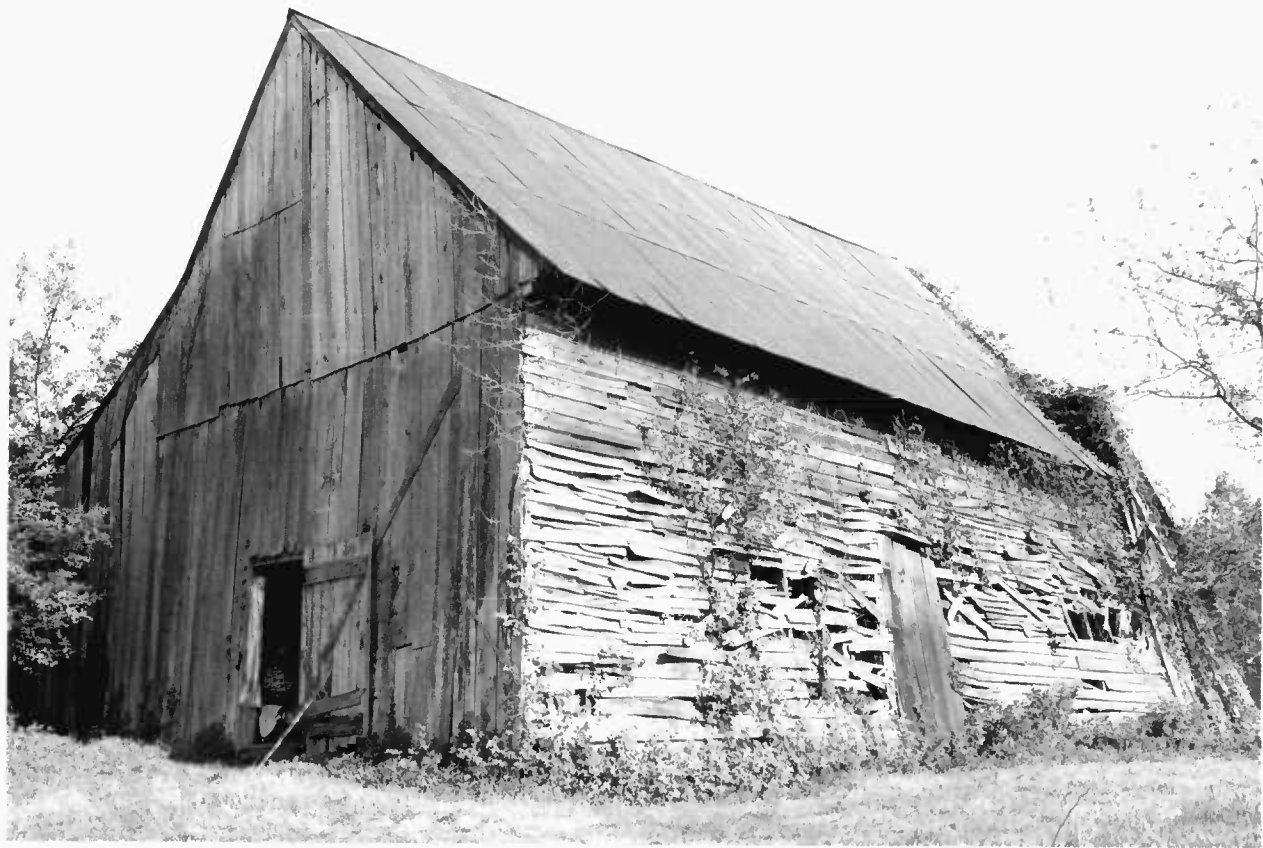
CT-97
Wilburne Farm
Barn #1
N.W. Corner

Barn #1: It will be noticed from the attached photograph that there is vertical siding on the north facade (most likely replacements) and horizontal siding on the west facade. Barns with horizontal siding (usually riven clapboards, 24" long 3" wide, feather edged and nailed to studs with cut nails) tend to be older in this area. Each side of the Wilburne barn has different siding. It is assumed that the west is original although it too has many patches. What was the east wall of the original barn is preserved by the shed addition on that side. Here the boards are 8" average width, butt end and feather edged. On some barns, horizontal siding is often overlapped on the ends as well as side edges, and clapboards on the south appear to be hand split and are C. 6" wide and 1/8" thick.

The degree to which the building is leaning makes measurements approximate, but it appears that the original barn measures 25' by 40' with 14' between the eaves and the ground. It is supported by a frame of hand hewn beams fastened by mortise and tenon with trunnels. Uprights and braces average 8" x 6 1/2" in thickness, foundation sills are 12" x 8 1/2" in thickness. The unusual feature of a tilted false plate has been noted in this barn.

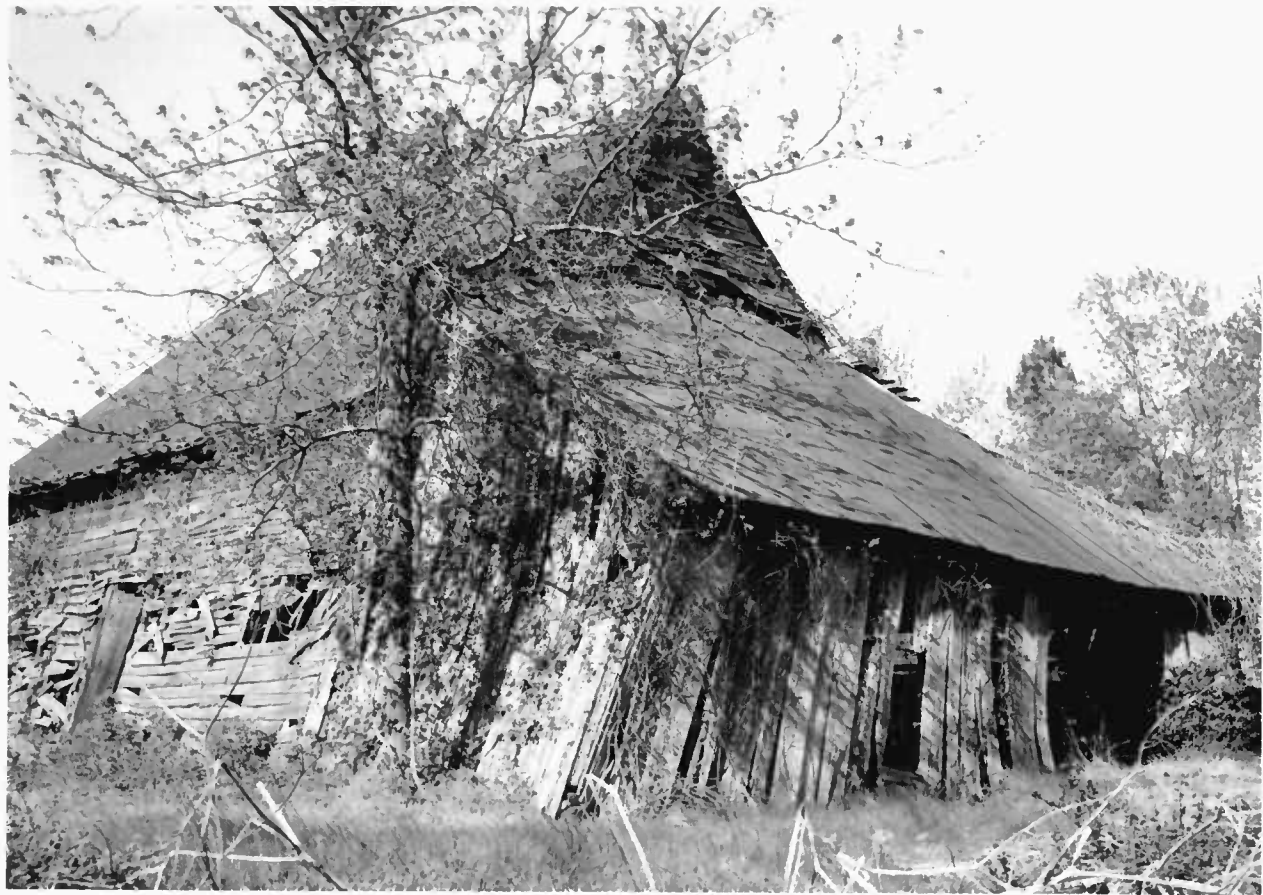
CT-97
Wilburne Farm
Barn

Barn #2: Almost identical to its neighbor on the next hill of the same farm, it too is clad with feather edged weatherboard on the sides and riven clapboards on the ends. It also has shed additions on the east and south facades. Both barns have central passage plans, are ten rooms long with three transverse sills. Both have post-and-beam frames utilizing tilted false plates in the eaves.
